DRAFT Arborist Report

**Gateway Village
Santa Clara, CA**

Prepared for:
**Essex Property Trust
925 East Meadow Drive
Palo Alto, CA 94303**

November 2012

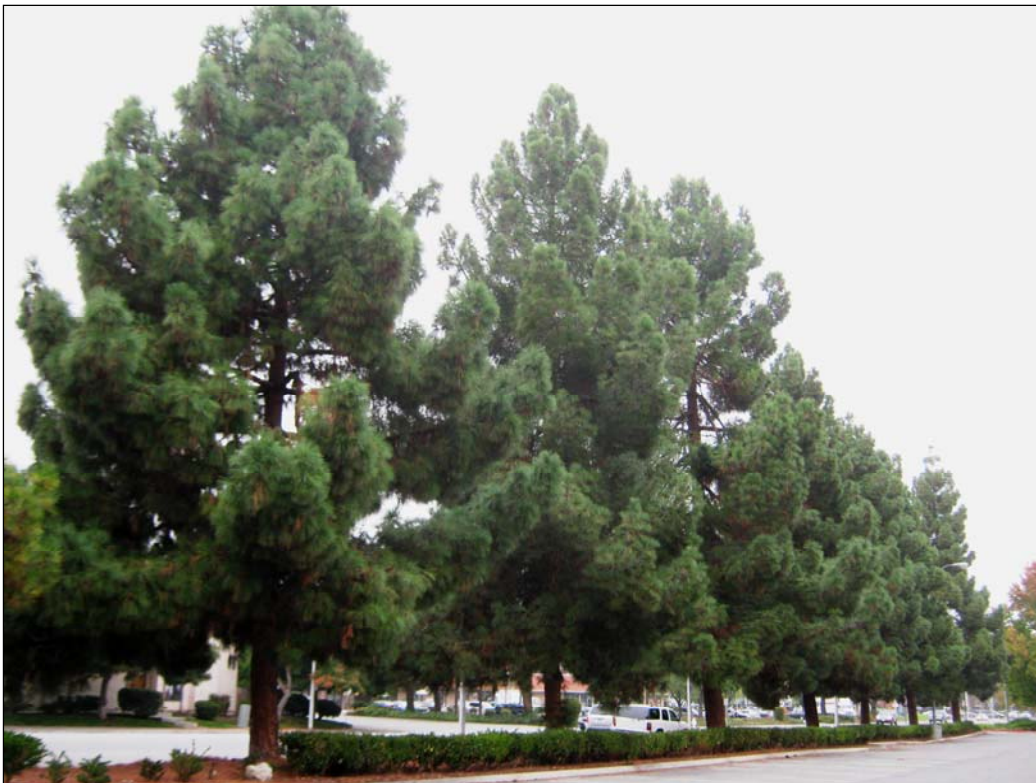
Canary Island pine, with 45 trees (25% of the population) was the next most commonly encountered species. These were the dominant, and most visually prominent, species on the site (Photo 1). Canary Island pines were semi-mature to mature in form and development, with 20 having diameters from 5-19" and 25 having diameters from 20-36". The species had performed well, with 35 trees in good condition (78%), nine (9) in fair condition (20%), and one (1) in poor. As is typical of the species, most had upright forms. Several of the trees in all conditions had long lateral limbs that could be managed through pruning to reduce branch length and extension.

Photo 1: Canary Island pines #19-25 (R to L) were growing in the landscape bed along Halford Ave. These trees were typical of the species at the site, with upright forms and long lateral limbs.
